TWO PERMANENT SOLUTIONS FOR ROTTED WOOD POSTS

REPAIR. REPLACE. RESTORE.

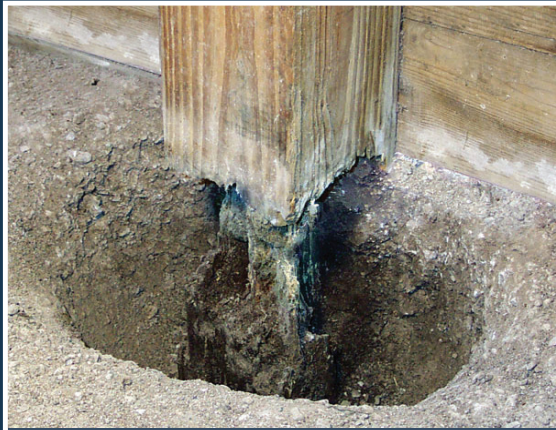
BEFORE

ROTTED POSTS?
